Chapter 2

EVENT RECONSTRUCTION

2.1.4. Cause of the Derailment

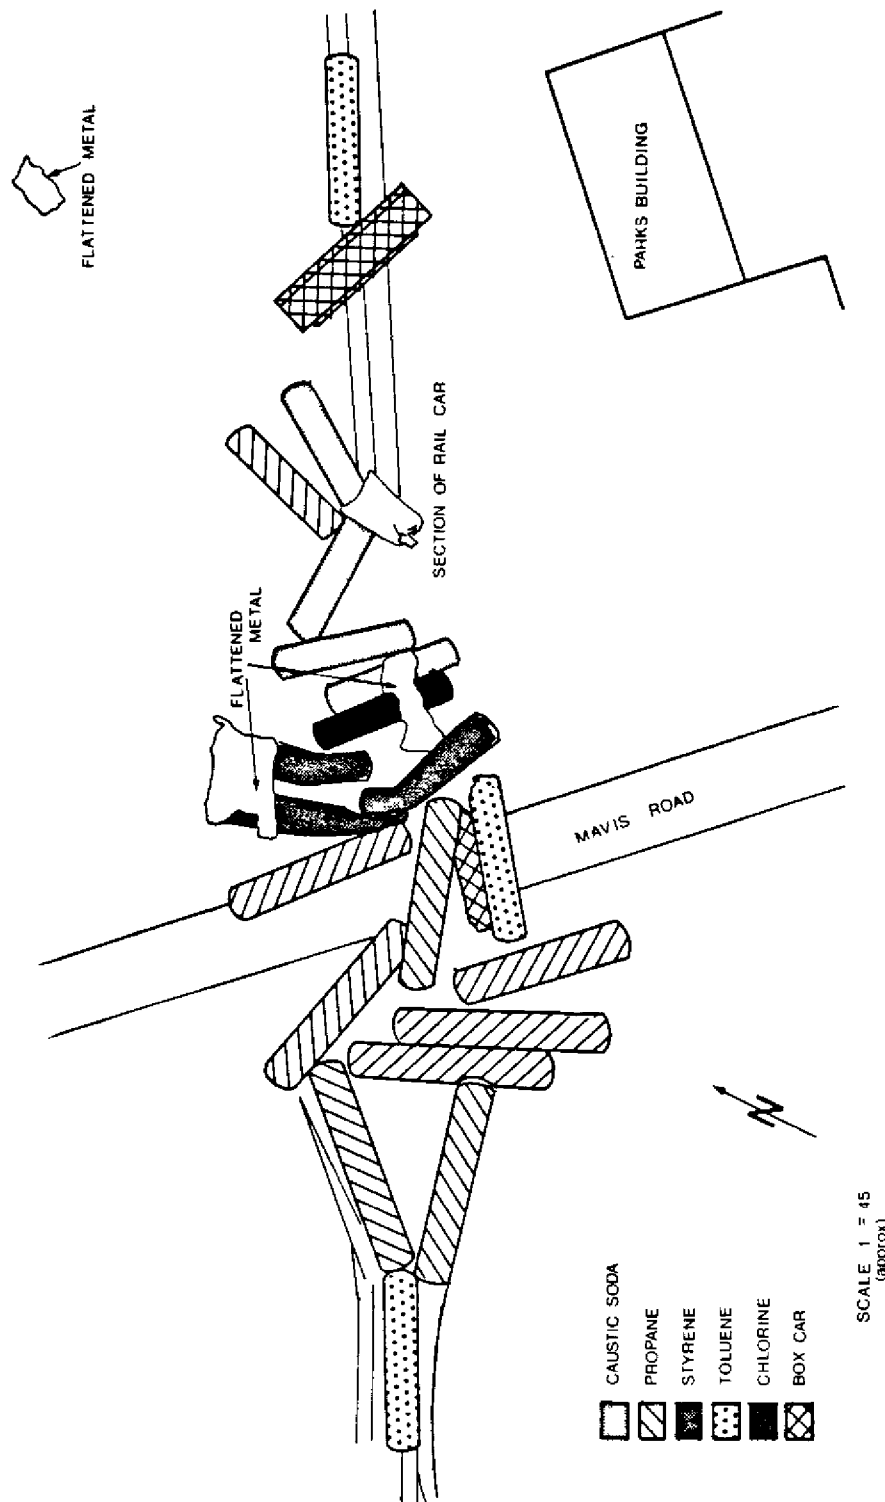
FIGURE 2.3 CONFIGURATION OF THE DERAILED CARS

Counting from Car 32 back (33 becomes derailed Car 1), 24 cars were derailed (Figure 2.3). Derailed car number 8 appears to have been the first propane car to experience a Boiling Liquid Expanding Vapour Explosion (BLEVE), which flung it 43.5 metres east. Other propane and toluene cars were punctured and ignited.

Behind them lay a jumble of cars, 24 in all (see Figure 2.3). At the heart of the jumble, possibly punctured by the BLEVE of Car 8, was Car 7, filled with 90 tons of chlorine. Ahead of it on the tracks were four cars of caustic soda (Cars 3-6); behind it were pieces of the BLEVE'd car of propane (Car 8), three twisted cars of styrene (Cars 9, 10, and 11), and a long string of propane cars (12, 13, 14, 17-23). All the propane cars were either ruptured or damaged, with their contents flowing off or exploding. The box cars burned. The styrene cars and caustic soda cars poured their contents onto the tracks, through punctures or damaged outlet valves, as did two of the toluene cars. The last car in the derailment, a toluene car, was found still to contain its cargo when the cleanup finally began some days later.

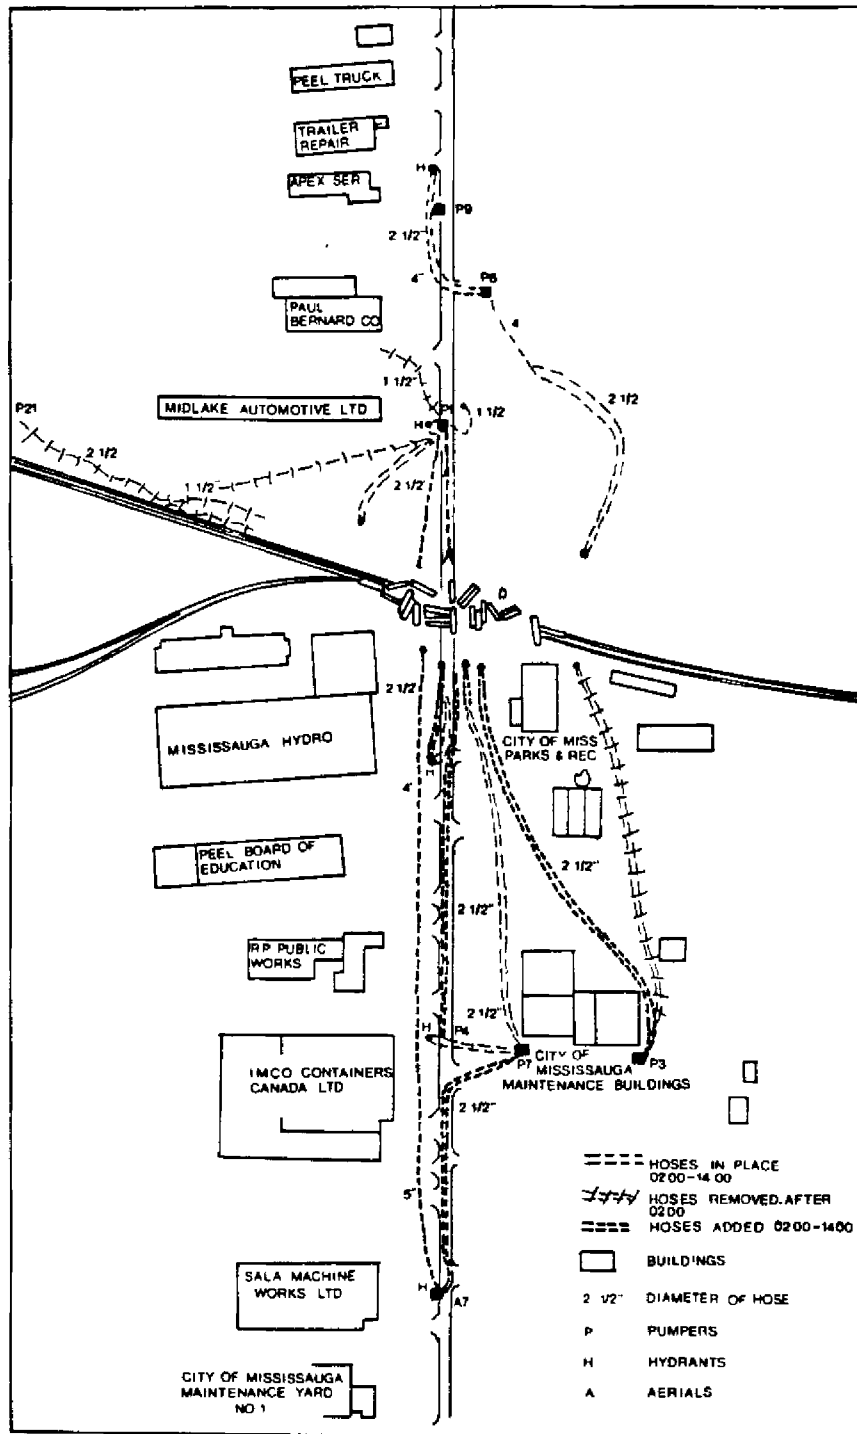
FIGURE 2.4 ARRANGEMENT OF FIRE HOSES AROUND THE ACCIDENT ON SUNDAY NOVEMBER 11, 1979

"What we did was to get in and put some lines on as the BLEVE's started to happen. Each time there was a new BLEVE, we'd have to leave everything and run. We started with three deluge sets from each side, and some hand units to put out spot fires."

The unmanned deluge sets worked automatically once they were set in place, and could pump 20,250 litres of water per minute on the fire. The difficulty was in getting close enough to the fire before another BLEVE occurred. Pumper trucks were sheltered behind buildings at some distance from the crossing, and firefighters had to lug hoses and deluge sets up to as close as 80 metres away before being able to turn and run to safety.
