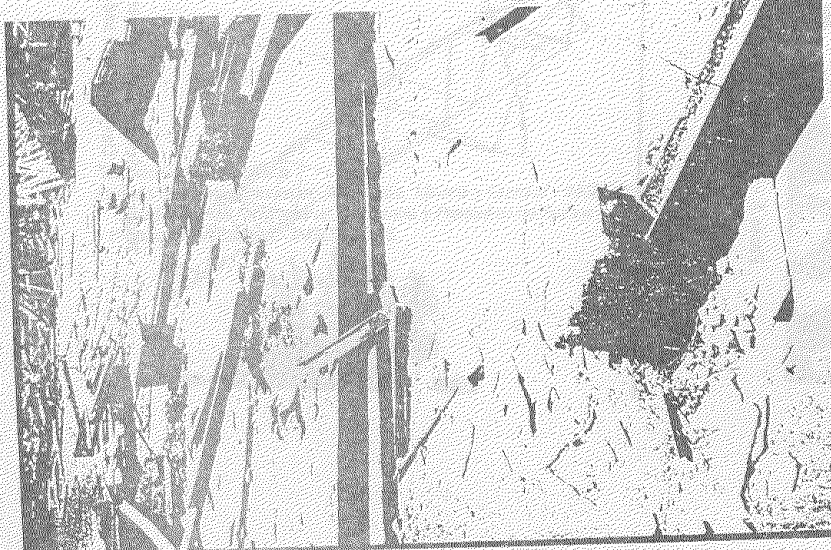
Photo 1 - Foundations (too small for lightweight building) pulled completely out of the ground (David)

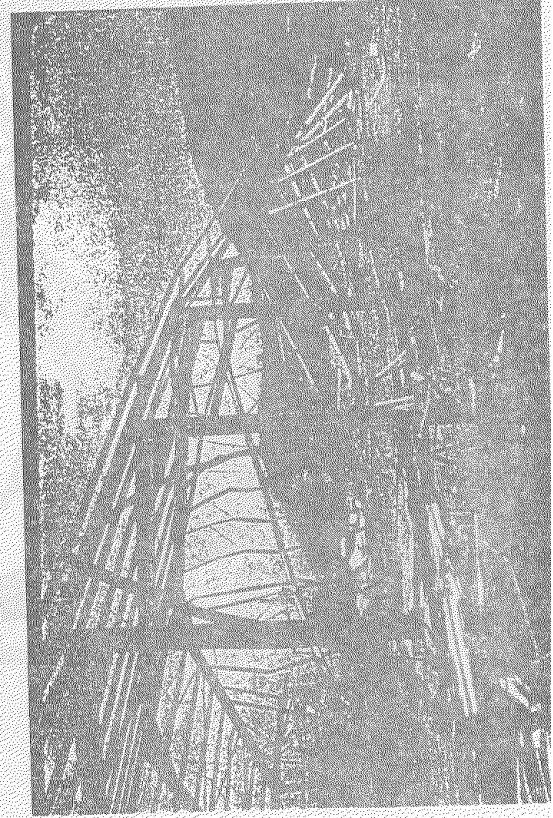
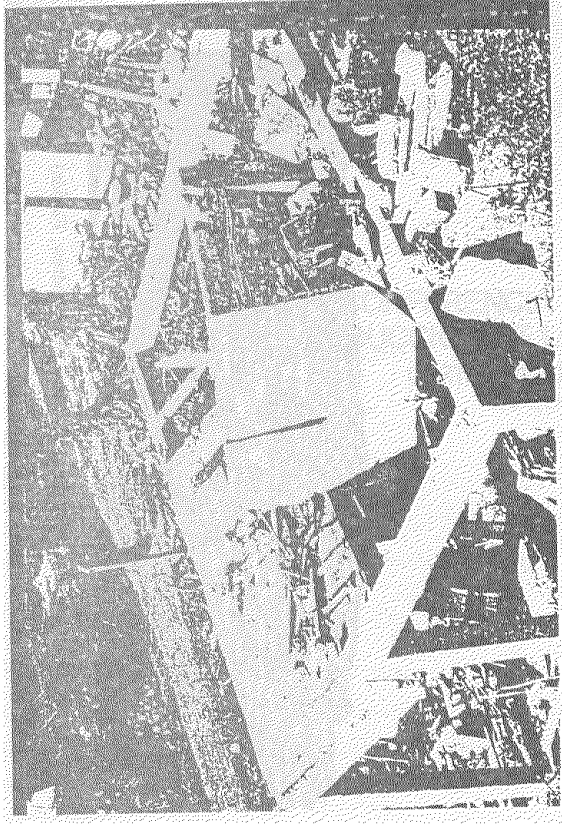
Photo 3 - Total loss of unreinforced concrete blockwalls and destruction of reinforced-concrete supports (David)

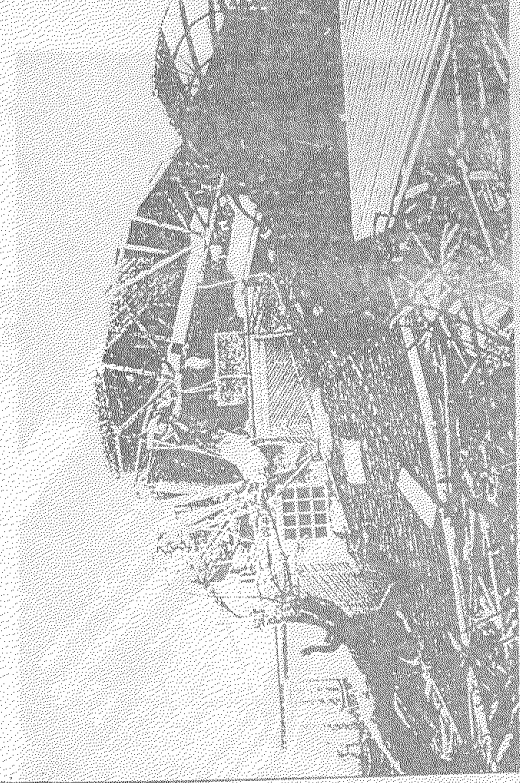
Photo 4 - Destruction of expensive former-farm residence (Andrew, Cal. CA) (Annamax)
