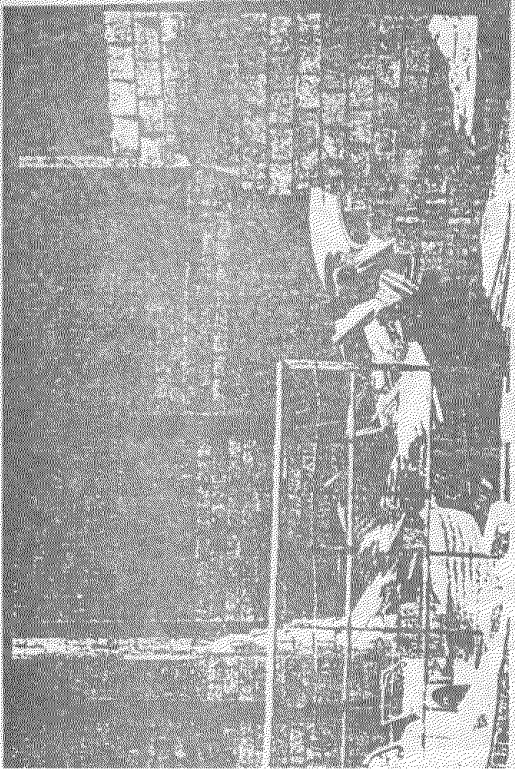
Photo 11 - Breaching of unreinforced blockwall (David)

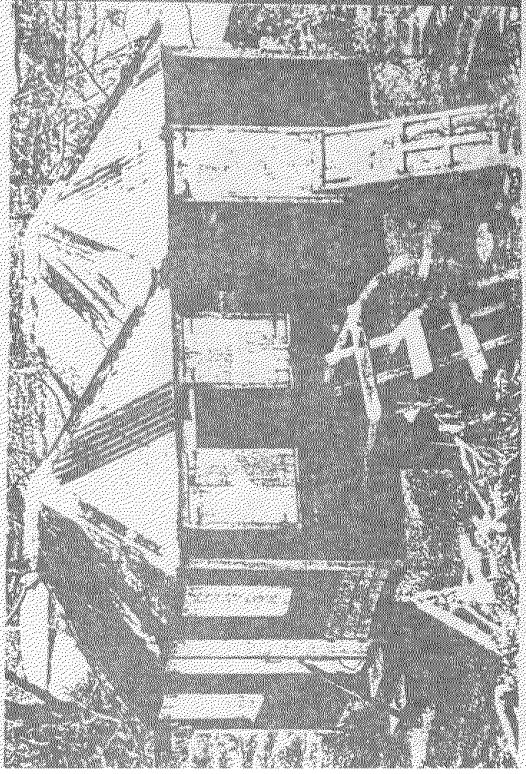
Photo 12 - The very favourable geometry saves this very modest house from any damage (Hugo)

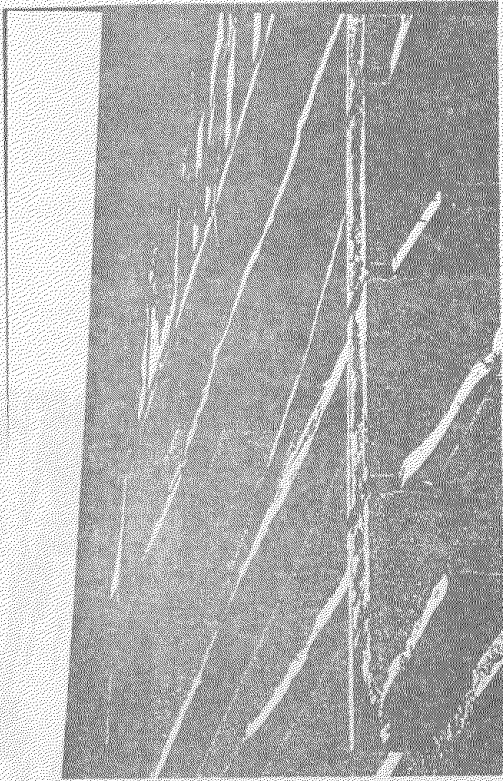
Photo 9 - Longitudinal splitting of timber rafters (Hugo)

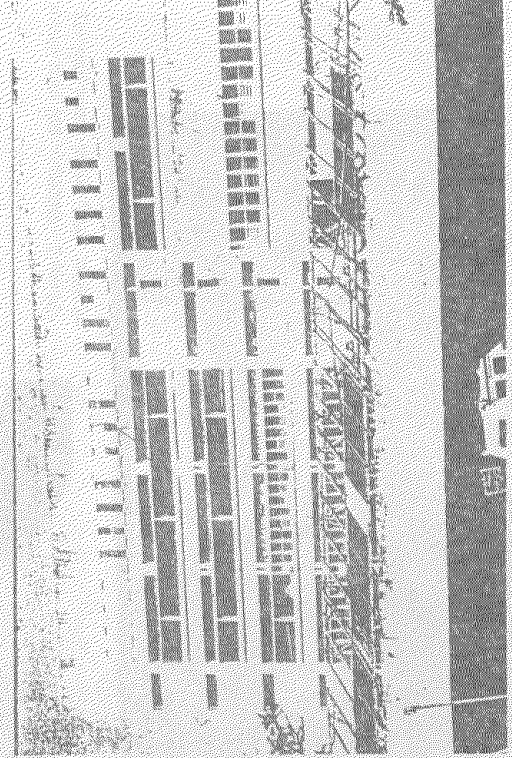
Photo 10 - Almost 100% loss of windows in the hospital. (Gilbert)
