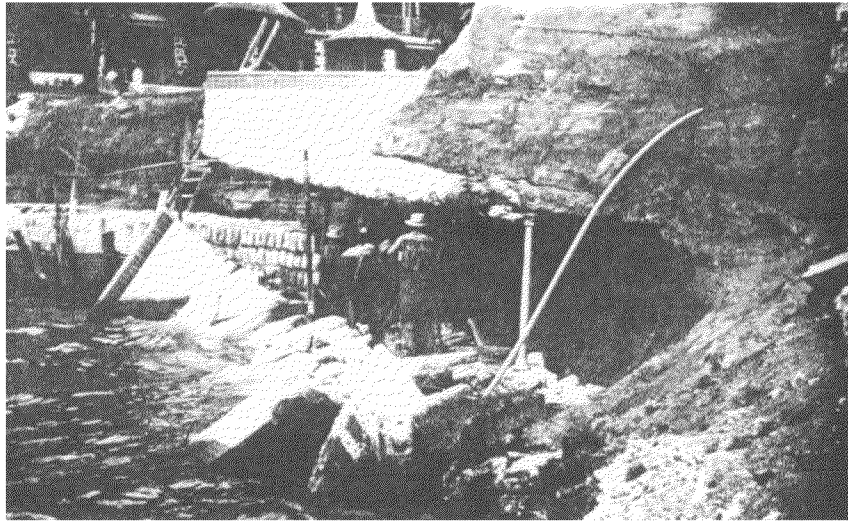
Figure 16. A house near Lake Atitlan viewed westward from the Panajachel River, illustrating lateral spread ground cracks (A), resulting cracks in the retaining wall (B), damage to the house (C), and subsidence (D).
