Chapter 2

EVENT RECONSTRUCTION

2.1.4. Cause of the Derailment

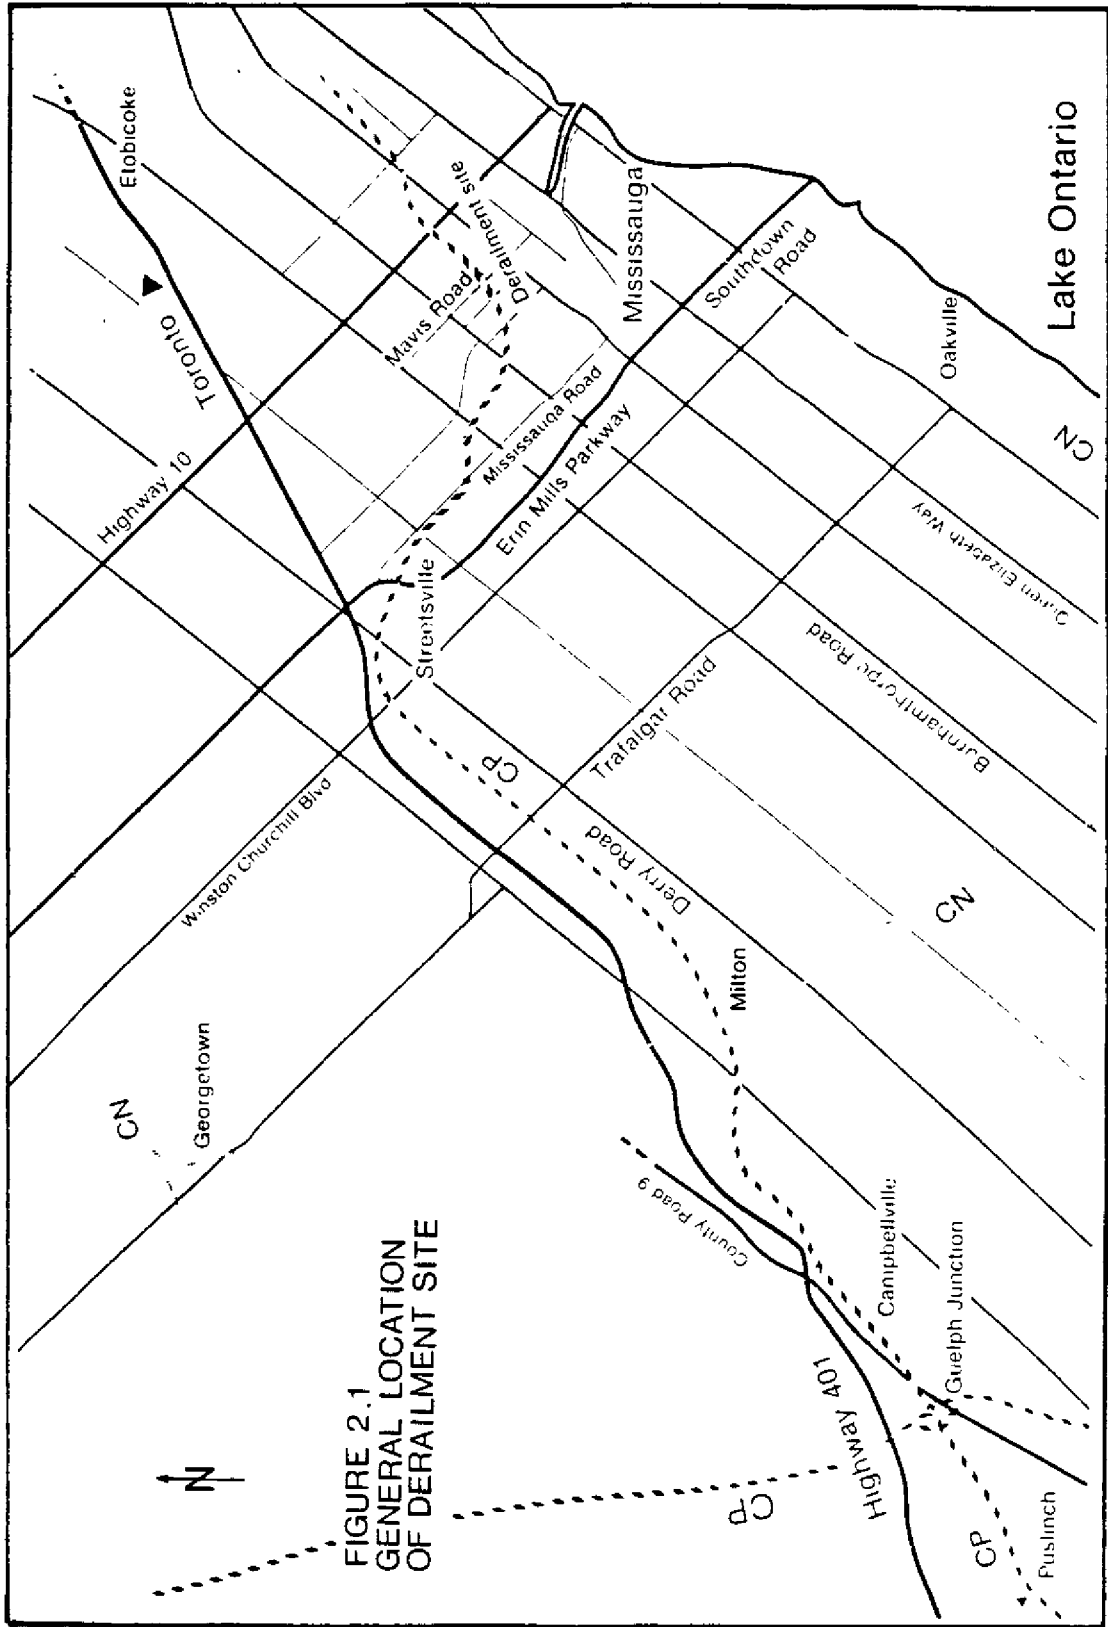
FIGURE 2.1
GENERAL LOCATION
OF DERAILMENT SITE

At this point, the testimony of witnesses to the passage of the train becomes relevant (see Figure 2.1 for locations mentioned).

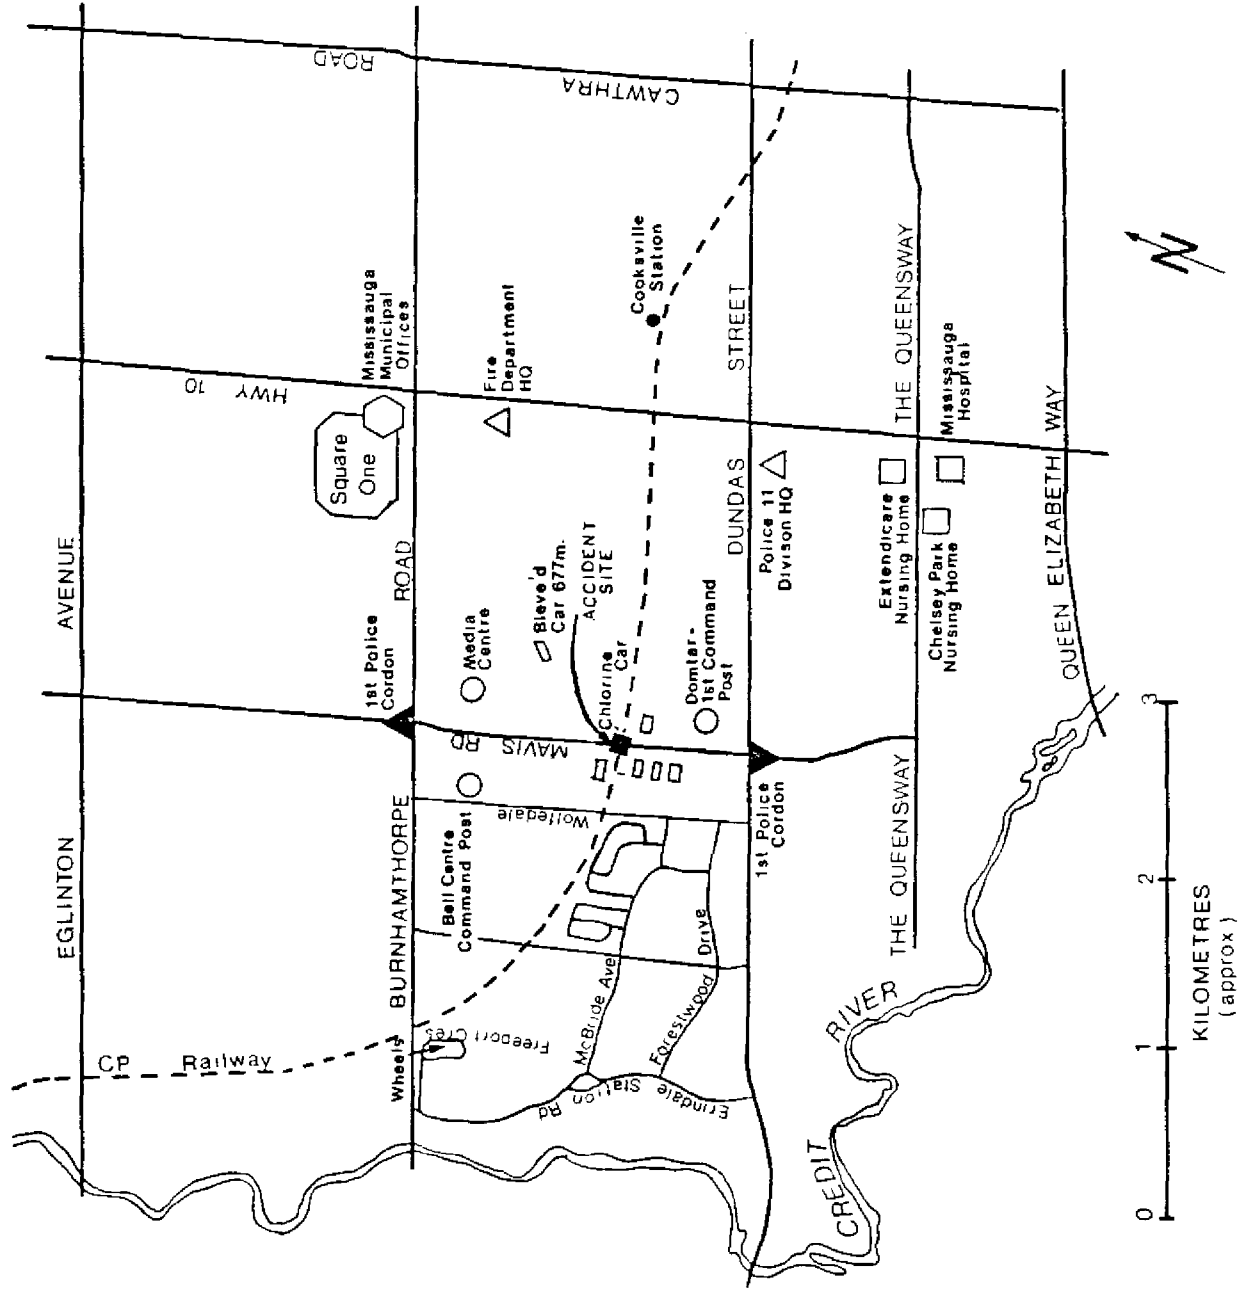
FIGURE 2.2 THE NEAR SITE

In his house on Eaglemount Crescent, the last street of houses before Mavis Road (see Figure 2.2), Peel Regional Police Constable Chuck McConnell heard the train approaching:

stay on the tracks past Wolfedale Road, it came into an industrial area again (see Figure 2.2). On either side of the next crossing, the Mavis Road crossing, are small factories and factory outlets, a Mississauga Hydro building, and Mississauga Parks and Works Department facilities. Beyond the crossing is the last significant space of open waste ground between Mississauga and Union Station in Toronto. About 1.5 kilometres further east, residential housing begins again. It was at this Mavis Road crossing, luckily enough, that the dangling undercarriage hit a switch to the Akaril Chemical Ltd. building and finally derailed.

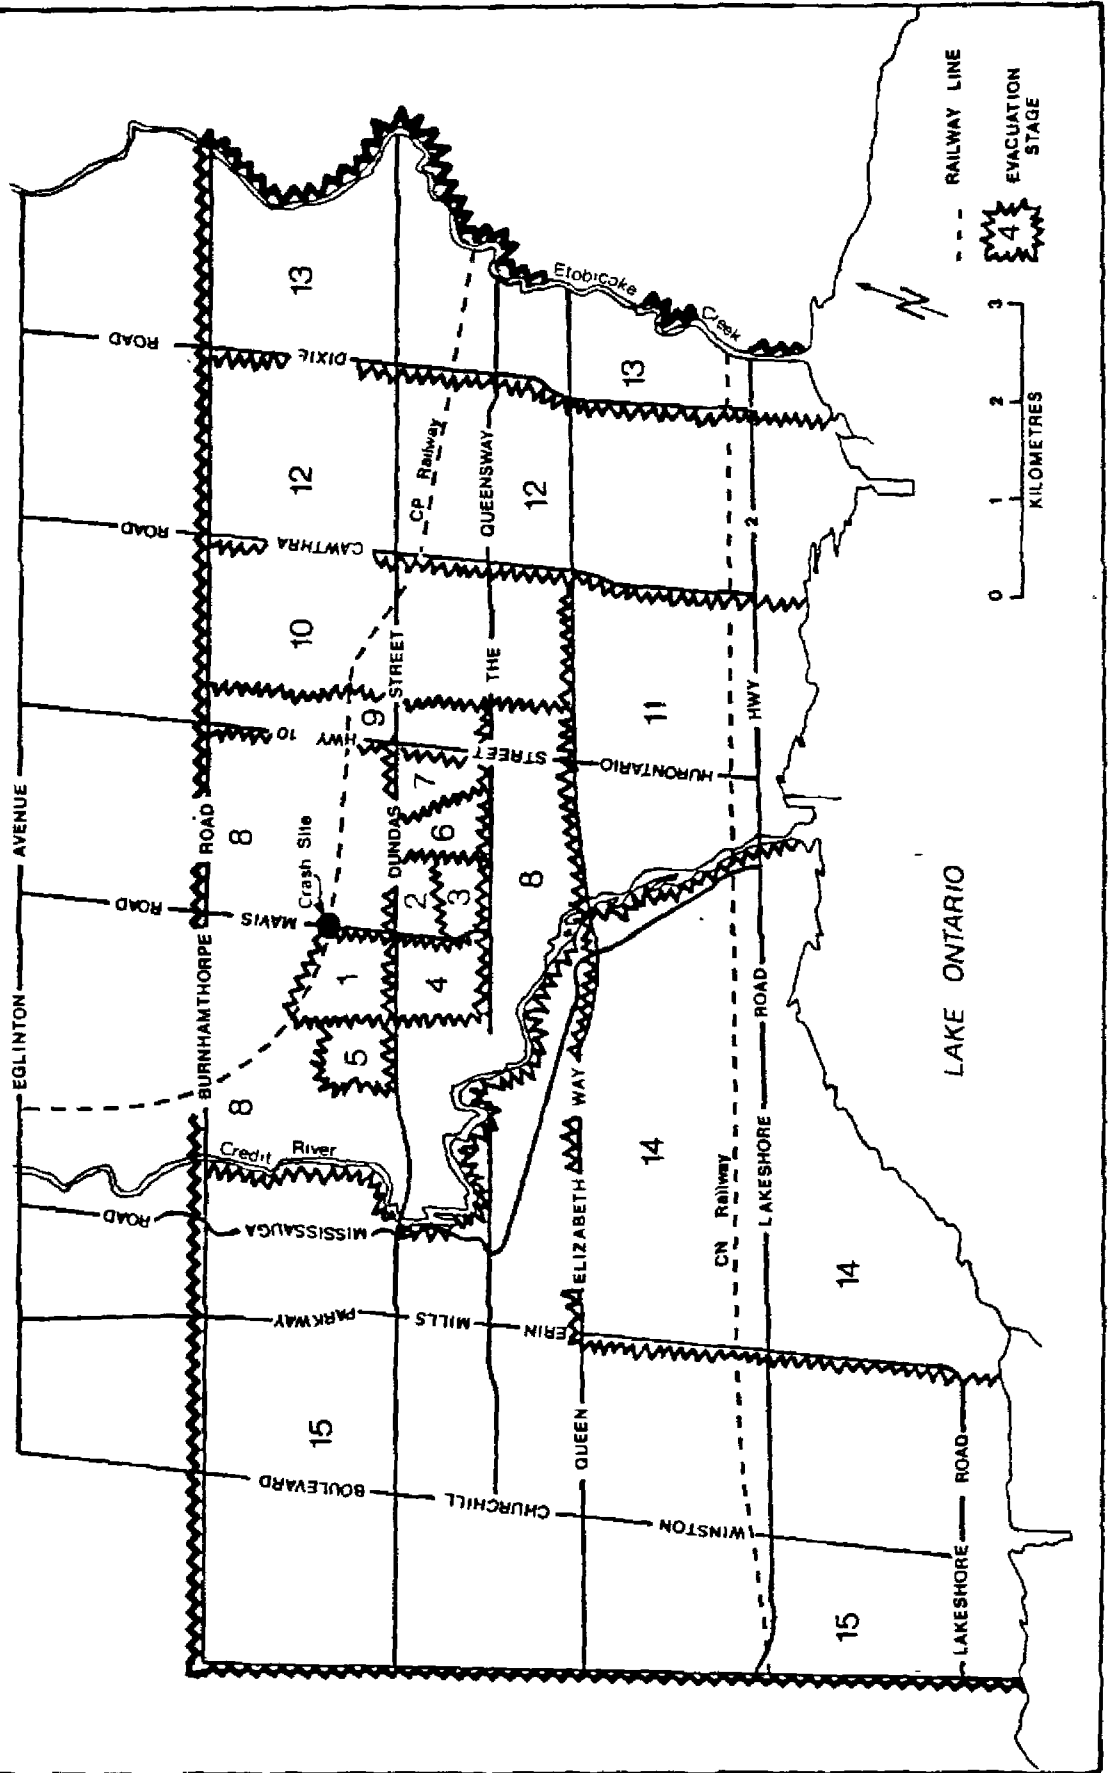
FIGURE 2.5 THE EVACUATION ZONES

At 04:15, the second stage of the evacuation was ordered, involving 350 people almost directly south of the site (Figure 2.5). Slightly later, at 04:31, all supervisory personnel south of the site were themselves evacuated to the north of the site. Bell
